From: Andrew MacKay, Envirochem **Date:** December 20, 2018
To: Anika Calder, VFPA **Cc:** Andre Olivier, PCT
Tiffany Paul, ECCC Colin Reddin, PCT
Mark Adams, Envirowest
**RE: PACIFIC COAST TERMINAL DREDGE WEEKLY MONITORING REPORT #2
DECEMBER 3-9, 2018 (SUMMARY REPORT)**

This report summarizes monitoring of PAH affected sediment dredging and disposal activities conducted in Port Moody Arm, BC for the week of December 3-9, 2018. All work continued under relevant permits issued by VFPA, ECCC, DFO and Transport Canada.

PCT PAH REMEDIAL DREDGE
WEEKLY MONITORING REPORT #2

DECEMBER 3-9, 2018

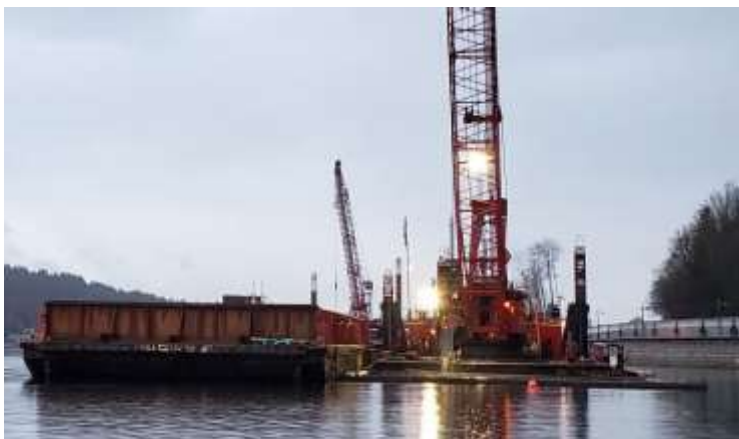
PAH remedial sediment dredging near Reed Point Marina with silt curtain frame and sealed scow.

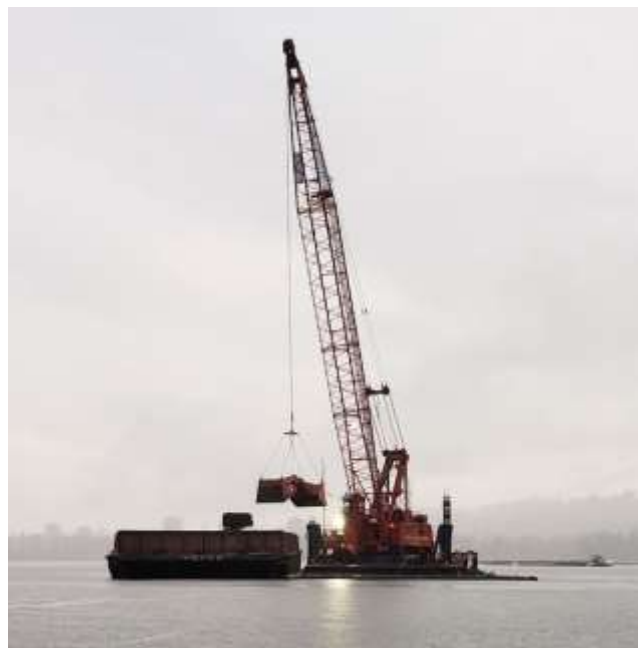
PAH remedial dredge disposal at designated location in new containment facility (west berm) using Envirobucket, silt curtain, suitable duty cycle and sealed scow.

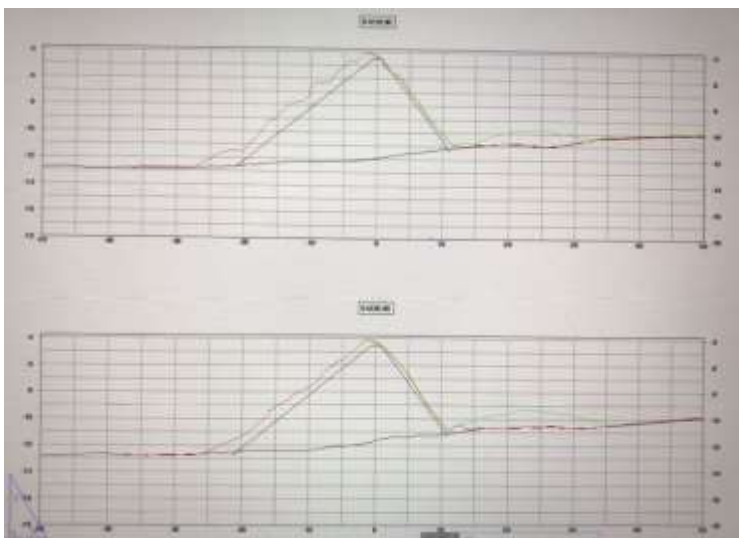
PAH affected sediment disposal cell cross sections showing berm (pyramid) and placed sediment (green line) on west side of berm.

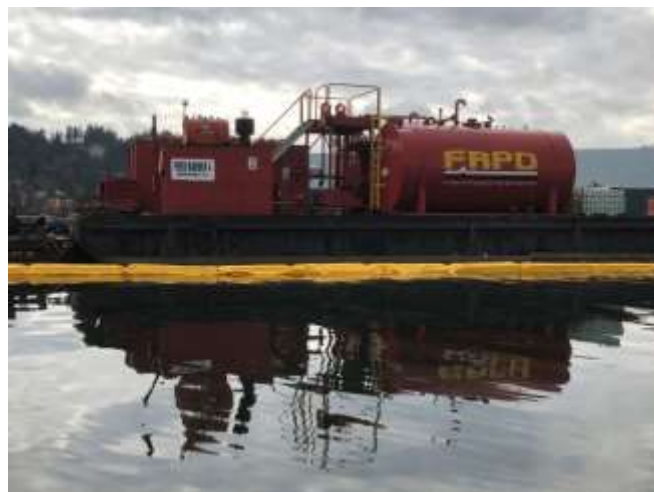
Bulk fuel storage barge. No sheen (spill) observed on water surface. Note: silt curtain (yellow) temporarily stored around barge.

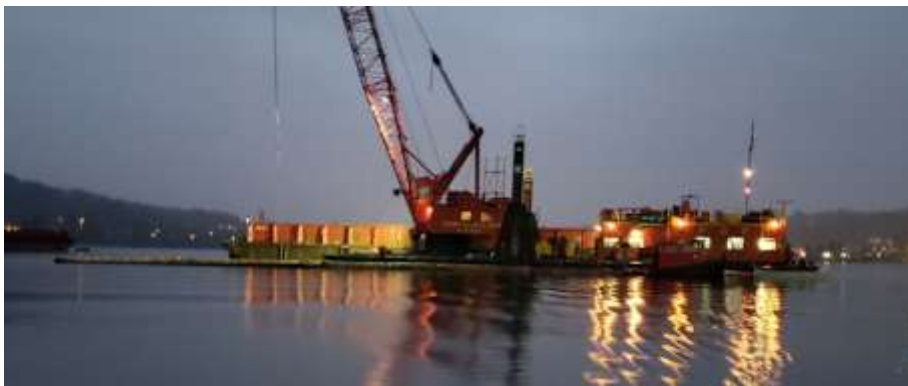
Though some heavy rains, calm water conditions prevailed during dredging operations.

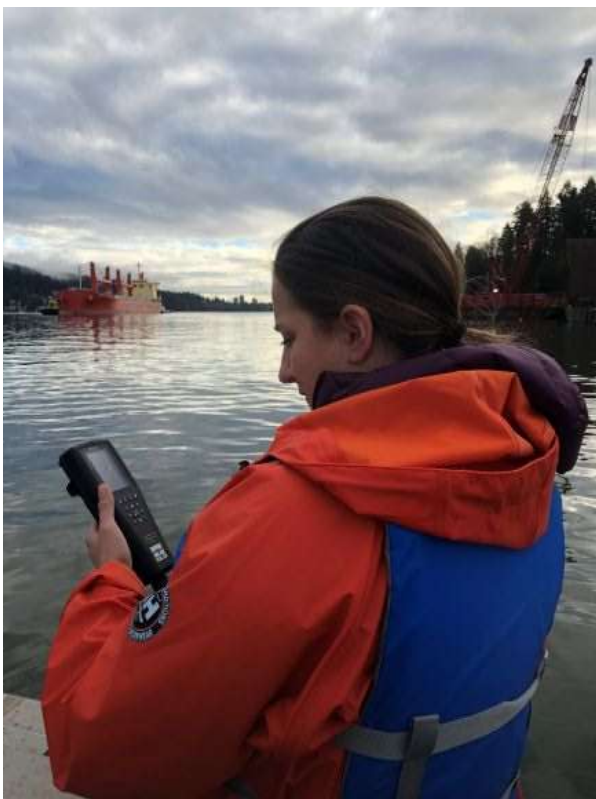
Daily open water turbidity monitoring using YSI handheld meter including probe on cable positioned to planned depths. Depth (surface, 1m, 3m and reference at 5m) readings are entered into mobile forms on an Ipad submitted on the internet to the Envirochem ENVOLV database for storage and reporting.

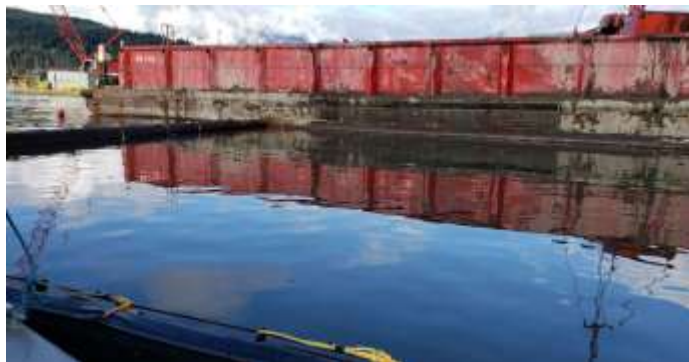
Continued use of silt curtain and sealed scow for dredging and transferring to dedicated disposal site in new containment facility (west berm).

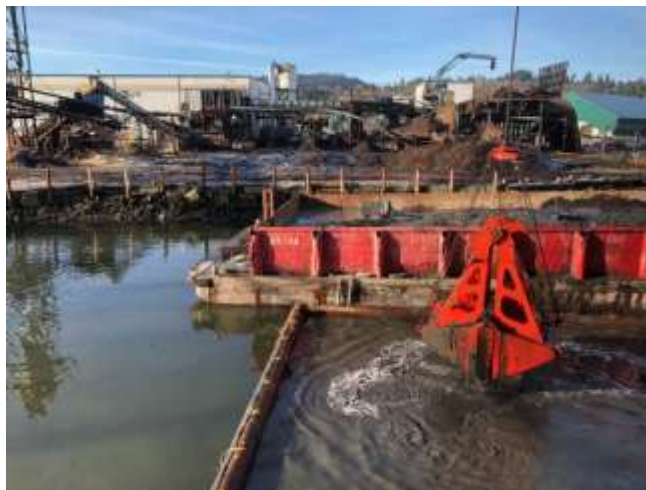
No work occurred December 9, 2018. December 3 and 4, 2018 was dedicated to remedial dredging of sediment spilled Flavelle Cedar sawmill in Port Moody. Works proceeded using the FRPD MacKenzie, Envirobucket, silt curtain and sealed scow. A total of 335m³ of spilled sediment was recovered from the adjacent upland area and scow berth pocket. FRPD had planned to dispose the material at a permitted upland facility.

Remedial dredge at Flavelle Cedar sawmill: Envirobucket, silt curtain and sealed scow. Recovered material sent for upland disposal.
